Inspection Report

123 Paradise Ln.

Inspection Date January 8, 2019
Client Happy Homeowner
Inspector Brandon Feltner
brandon@rangerinspect.com
TREC # 22952

PROPERTY INSPECTION REPORT

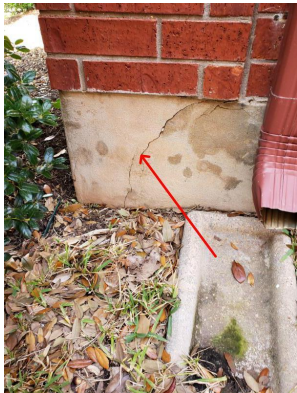
Item	Slab
	Concern	Corner pops
	Location	Exterior: Ground View
	Impact	These are usually cosmetic and don't affect the structural integrity of the slab. If exceptionally large, they can reduce the support for the masonry wall.
	Suggested Action	Monitoring for worsening. The corners can be repaired by gluing them back on with an exterior epoxy if desired.
	Other Information	These cracks are considered common in some slab foundations.

At multiple corners;
This one is of the right
front corner.

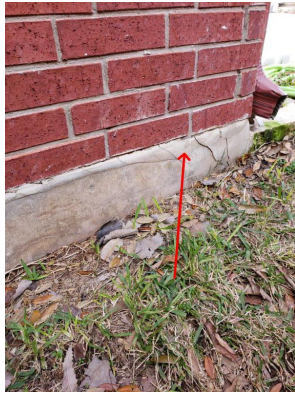
Multiple locations
around the home

Item Slab
Concern Minor cracking/spalling of parging coat.
Location Exterior: Ground View
Impact Minor cracking/spalling is a cosmetic issue. It can happen seasonally through freeze/thaw cycles & as new construction cures.
Suggested Action Make sure the masonry can dry by eliminating any source of chronic moisture and monitor over time.
Other Information Spalling is a result of water entering brick, concrete or natural stone and forcing the surface to peel, pop out or flake off.

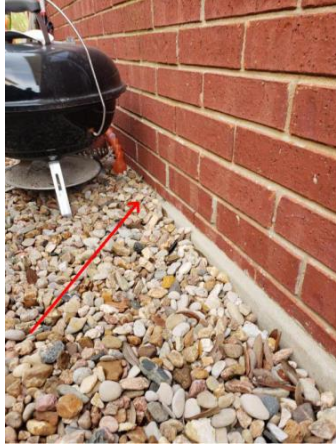
Left side of home

Item Drainage and Grading
Concern Soil level is a little too high
Location Exterior: Ground View
Impact When soil levels are high against the face of the foundation it promotes water penetration, moisture damage to siding and insect intrusion.

Other Information It is generally accepted that a brick/stone veneer house should have about 4 inches or more of clearance between the top of the foundation wall and the soil line. The parging coat has been applied up on the brick wall, giving the illusion that that the foundation is higher than it actually is.

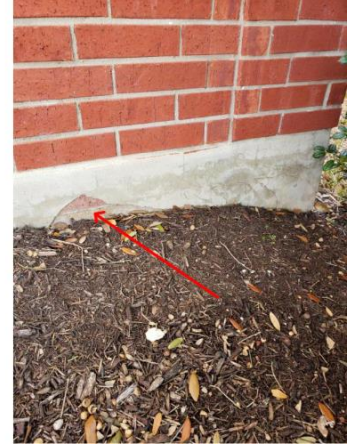
Front of home arrow indicates the top of the foundation wall

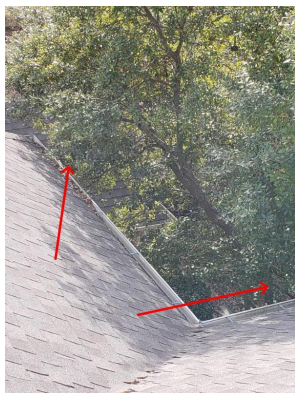
Tree in front yard

Item Landscape Feature
Concern Tree branches are in contact with or very close to the building
Location Exterior: Roof View
Impact The tree branches provide an environment where moisture and/or insects could intrude and also may cause damage or excessive wear to the siding or roofing material.

Other Information Trees that are too close can allow access to animals, such as squirrels. These animals may chew on siding or attempt to enter the home or attic to nest.

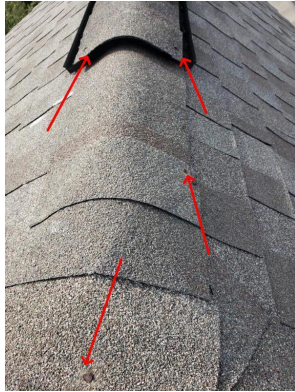
Roof ridge

Item	Roof Material
Concern	Exhibits exposed nail heads
Location	Exterior: Roof View
Impact	If left unattended over time, it could be possible for the nail head to deteriorate & allow water to damage the wood sheathing.
Suggested Action	Apply roofing cement to cover the existing nail head.

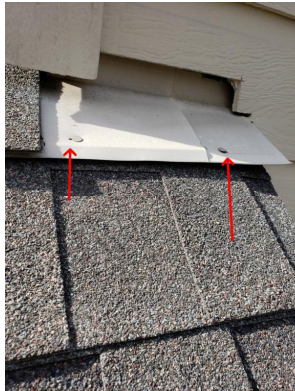
Above back patio deck

Item	Roof Flashing
Concern	Exposed fasteners
Location	Exterior: Roof View
Impact	Exposed fasteners present an increased risk of leakage. Water/moisture can get in and under the roof covering at these locations & even corrode the fastener.
Suggested Action	Seal the fastener with a dab of pliable exterior caulk.

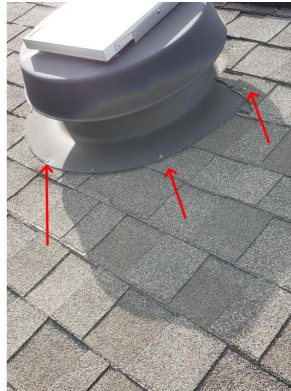
Both turtle vents

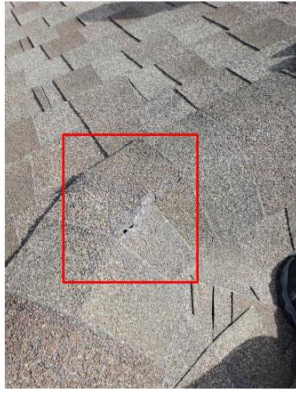
Item	Roof Material
Concern	Minor damage in isolated areas
Location	Exterior: Roof View
Impact	The damaged areas may eventually expose the underlying sheathing to potential water damage.
Suggested Action	Monitor. If conditions worsen, have a licensed roofing contractor repair or replace the damaged areas.

One ridge cap shingle

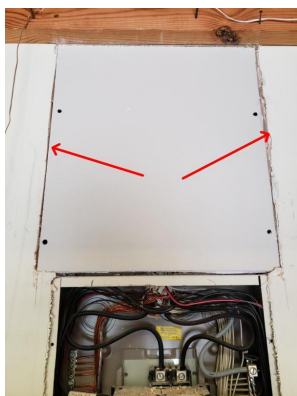
In garage above sub panel

Item	Wall
Concern	Fire blocking is inadequate
Location	Attached Garage
Impact	A fire wall/blocking is meant to stop or slow down the spread of fire from the garage to the home.
Suggested Action	Have a contractor repair the wall so that the fire blocking is corrected. This is usually done with normal tape & float.

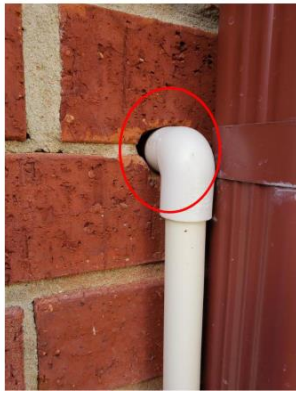
Left side of home

Item	Siding
Concern	Hole in exterior wall siding
Location	Exterior: Ground View
Impact	Water, insects, and pests may enter here causing damage to both the inside and outside walls.
Suggested Action	Seal the cracks with a flexible exterior epoxy.
Other Information	This piping is used as conduit for the irrigation system wires.

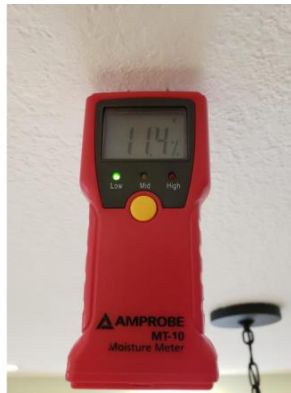
Moisture content reading

Item	Ceiling
Concern	Thermal anomaly observed
Location	Kitchen
Impact	A cool spot was detected with thermal imaging. A moisture meter did not indicate excessive moisture at the location. Source of the anomaly could not be confirmed.
Suggested Action	Continue to monitor this area. If conditions worsen, contact a licensed contractor to evaluate the source behind the ceiling.
Other Information	This could be caused by a number of factors ranging from no concern at all to a future concern if things worsen. (Examples of possibilities are; a small water leak, cool air leak in the ductwork or simply missing insulation where a light fixture used to be as this kitchen has been remodeled.

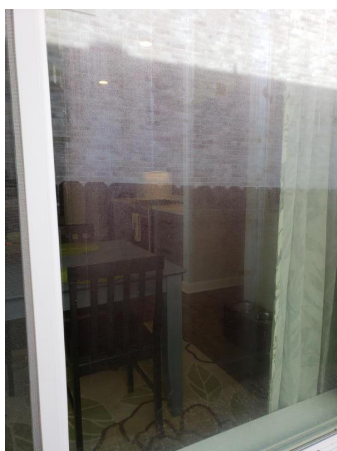
Item	Window
Concern	Fogging or sweating
Location	Master Bedroom, Kitchen, 3rd Bedroom
Impact	Visibility through glass is reduced. Condensation may appear and disappear, leaving the interior surface dirty.
Suggested Action	Replace the glass as desired. Usually a window repair company will first come out to measure the window glass so that they can make the correct size for your window and then a second time to install it.
Other Information	This is likely caused by a broken seal. Temperature differences between the indoors and outdoors creates condensation on the interior of the glass. Despite the appearance, the window may still perform reasonably well from an energy efficiency standpoint.

This is a view of the window at the breakfast nook. Other windows include the master bedroom & 3rd bedroom

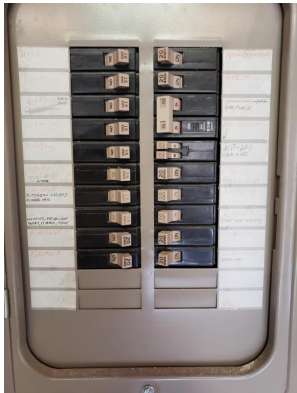
Sub panel in garage

Item	Sub / Distribution Panel
Concern	AFCI not present at every location now used in today's building standards
Location	Attached Garage
Impact	This is a common find with older homes as these breakers may not have been available or required at the time constructed. AFCI's are meant to detect arc-faults and interrupt power to prevent potential dangers.
Suggested Action	While not required, it is recommended for the absolute safest operation,to have a licensed electrician install AFCI protection to appropriate circuits.

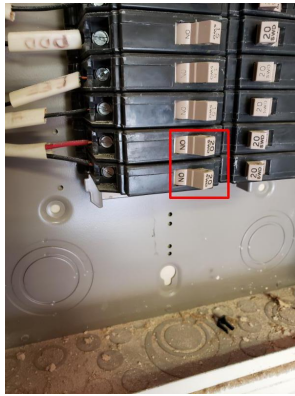
Sub panel in garage

Item	Sub / Distribution Panel
Concern	Breakers not tied together
Location	Attached Garage
Impact	When one circuit is powered by 2 "hot" wires that share 1 neutral wire (aka. multi-branch circuit) Each "hot" is connected to its own separate breakers. Those 2 breaker handles should be tied together so that if 1 breaker is tripped (shut off) because of overload or a short, the other breaker gets turned off also, to protect the circuit.
Suggested Action	Have an appropriate breaker tie installed by a licensed electrician or qualified person.

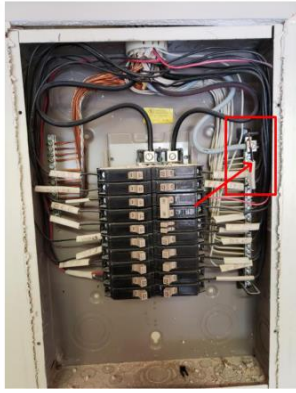
Sub panel in garage

Item	Sub / Distribution Panel
Concern	Wire is uncapped
Location	Attached Garage
Impact	The wire is not live but it could cause arcing if it comes in contact with any electrically charged components.
Suggested Action	Have repaired by a licensed electrician or qualified person cap & secure the wire or remove entirely.

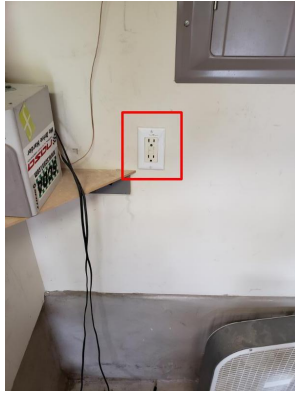
Item	GFCI
Concern	Inoperative
Location	Attached Garage
Impact	Lacks ground fault safety
Suggested Action	Have a licensed electrician or qualified person replace with appropriate receptacles for GFCI protection.

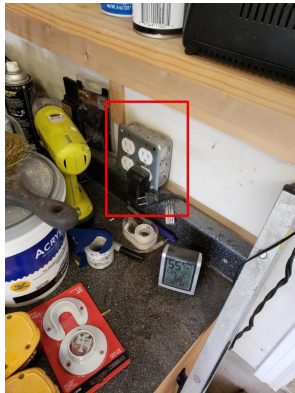
In garage

Item	Outlet
Concern	Metal outlet cover not bonded to ground
Location	Attached Garage
Impact	This is a safety hazard but also relatively easy to correct. The purpose of bonding the metal cover plate is to give it a path to de-energize should it ever become electrically charged.
Suggested Action	Have a licensed electrician bond the cover plate and junction box or simply replace them with non-conductive plastic cover plates.

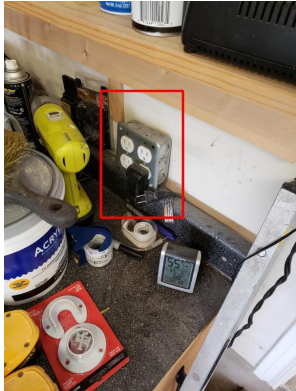
Item	GFCI
Concern	Not present at all garage receptacles
Location	Attached Garage
Impact	This is a common find with older construction as it may not have been required at this location during the time of construction. Without a working GFCI, hazardous grounding will not be detected and interrupted.
Suggested Action	Have a licensed electrician or qualified person upgrade the appropriate receptacles or circuits to GFCI protection.
Other Information	New building standards NOW call for all garage receptacles to have GFCI protection.

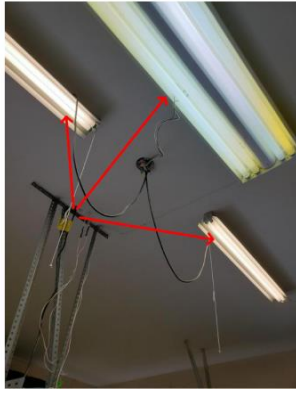
Garage lights

Item	Light Fixture
Concern	Cover missing
Location	Attached Garage
Impact	The cover is meant to protect the glass bulb from getting broken, wires from damage & help prevent electrocution.
Suggested Action	Install appropriate light cover.

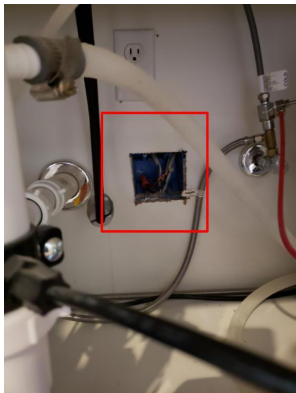
Under kitchen sink

Item	Junction Box
Concern	Cover plate is missing
Location	Kitchen
Impact	The cover separates you from the wires inside and helps to prevent electrical shock.
Suggested Action	Install a cover plate.
Other Information	Cover plates are abundant at home improvement or electrical supply stores and relatively inexpensive. There are many styles so be sure to get the appropriate one for the junction box.

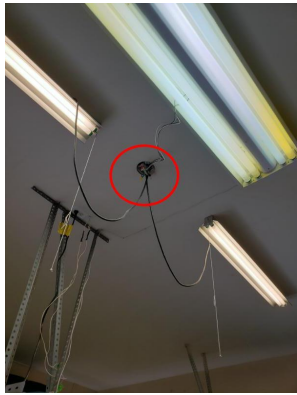
Garage lighting

Item	Wiring
Concern	Junction box is missing a cover plate
Location	Attached Garage
Impact	Without a junction box cover the wiring is exposed thus lacking protection from shock or arcing.
Suggested Action	Install a cover plate. A licensed electrician may be necessary as this will require re-routing the ballist wires .

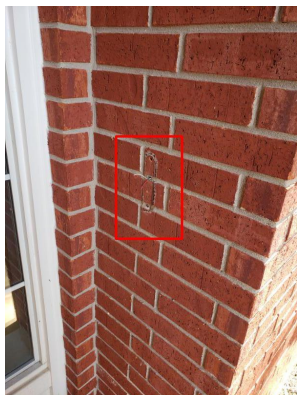
At front door

Item	Door Bell
Concern	Not Present
Location	Exterior: Ground View
Suggested Action	Have a doorbell installed if desired.

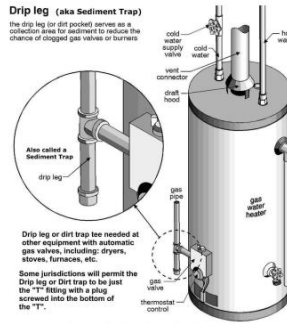
Downstairs HVAC system

Item	Furnace 2 (downstairs)
	Concern	Sediment trap missing
	Location	Main Attic
	Impact	Without a location for the condensation or sediment in the supply gas to escape, the moisture could cause corrosion or damage the ignition components of the unit.
	Suggested Action	Have repaired by an HVAC service professional; A plumber may be required to install sediment trap to the fuel plumbing.
	Other Information	This is typical of older installation. While not a big deal, it is incorrect

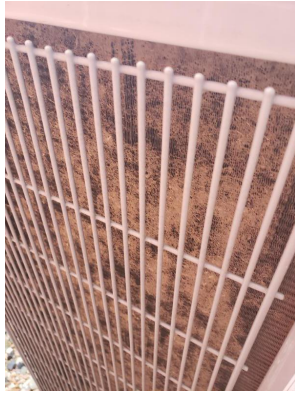
Item AC-Condenser 2 (downstairs)
Concern Condenser fins are excessively dirty
Location Exterior: Ground View
Impact Dirty fins restrict the amount of air flow over the condensing coil. If less air flows over the coil, less heat is removed. That means the whole cycle warms up a bit, and your AC works harder to keep your home cool.
Suggested Action Wash the fin to clean out dirt. Use very low pressure as fins are very fragile.
Other Information The fins on a condenser allow air to flow smoothly through and out of an air conditioner.

This is the older unit

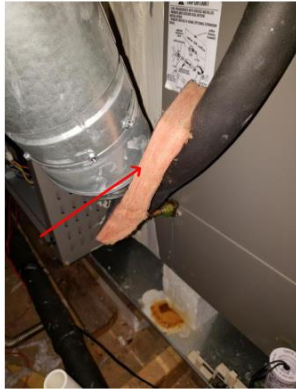
Upstairs HVAC system
(newer system)

Item HVAC Venting
Concern Vent connector is too close to combustibles
Location Main Attic
Impact The material (insulation) touching the furnace vent flue represents a fire issue.
Suggested Action Have repaired or re-routed by an HVAC professional.
Other Information This is improperly being used to separate the refrigerant line from the furnace vent pipe.

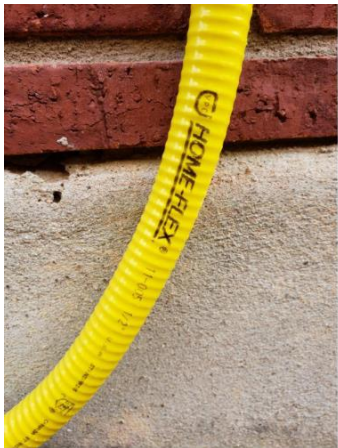
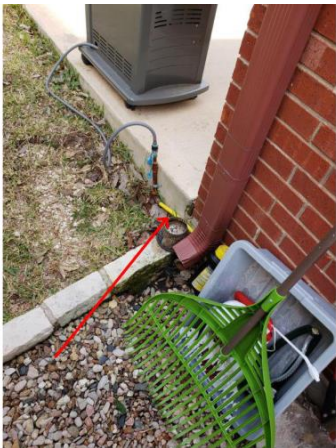
Left side of home

Item	Fuel Lines
Concern	CSST Improper install
Location	Exterior: Ground View, Laundry Room / Mudroom
Impact	The CSST pipe to the bbq grill does not appear to be properly bonded or supported along the exterior of the home. It is also buried, which is not appropriate for some brands.
Suggested Action	I suggest having a licensed plumber evaluate & improve this installation or remove it entirely.
Other Information	CSST has been found to be susceptible to damage from arcing by direct or nearby lightning strikes.

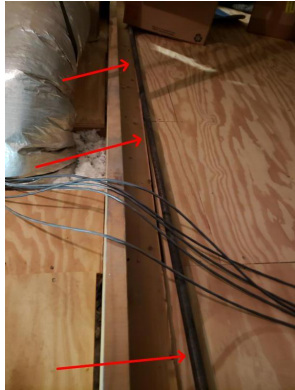
2nd/walk-in attic

Item	Fuel Lines
Concern	Not properly secured
Location	2nd Attic
Impact	An unsecured line can flex or move which has the potential to loosen connections creating a gas leak. Have a licensed plumber properly secure the fuel line to prevent movement.
Suggested Action	
Other Information	The line should simply have more securing straps at appropriate intervals.

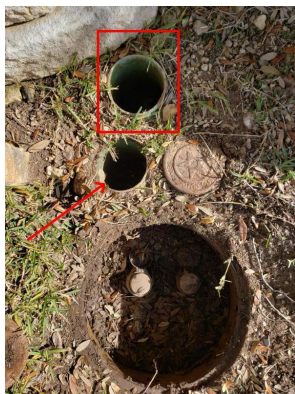
Right side in front of retaining wall.

Item	Main water valve
Concern	The metal lid is the water meter. The middle pipe with the arrow is the main water shut off valve. The top pipe in the square is a possible water pressure reduction valve. The handle is missing from the shutoff. The possible pressure reduction valve is rusted and covered with dirt.
Location	Exterior: Ground View
Impact	Inability to shut off the water in the event of an emergency.
Suggested Action	Have this repaired by a licensed plumber.

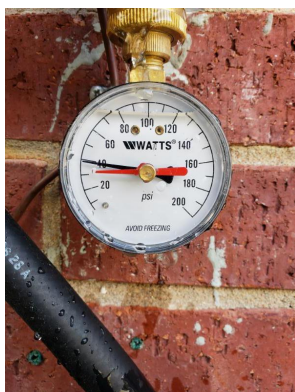
Observation Water pressure is 40 psi & in the recommended range of 40 to 80 psi. This is, however, at the bottom of the range. Contact a licensed plumber to increase the pressure if desired.

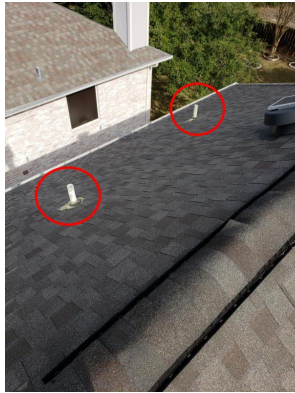
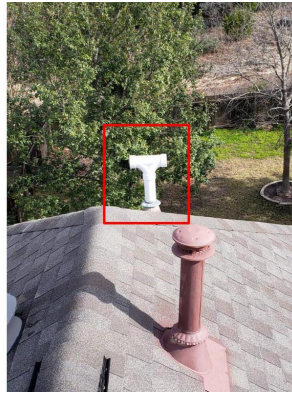
All plumbing vents

Item	Plumbing Vent
Concern	Not Painted
Location	Exterior: Roof View
Impact	Without paint, the UV rays from the sun will cause premature wear.

Suggested Action Paint the PVC pipe with an exterior paint. A paint color matching the homes theme or other vents is typically the favored choice.

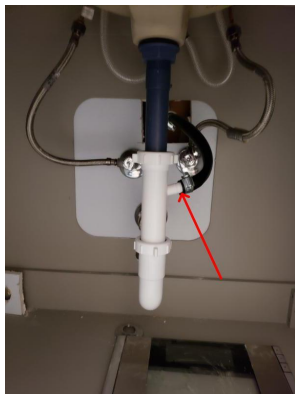
Under 2nd bathroom sink

Item	Waste Discharge Pipe
Concern	Minor Leaking
Location	2nd Bathroom
Impact	The leak can cause damage to the cabinets, walls and flooring.
Suggested Action	Have repaired/replaced by a licensed plumber or qualified person. The hose clamp may just need to be tightened.
Other Information	Since this is for the condensate drain of the HVAC system, it may go unnoticed until the system is ran on the cooling cycle.

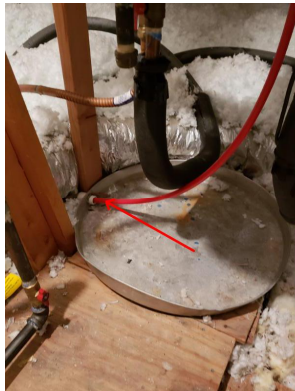
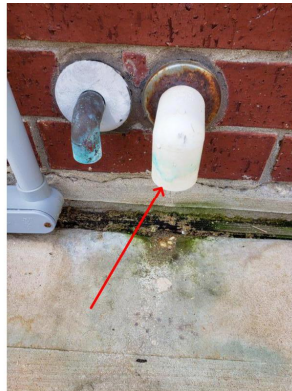
At water heater in attic

Item Water Heater
Concern Condensate drain line discharge improper
Location Main Attic
Impact This is a condensate drain line for the water heater. It will continually drip water which is normal, however, it is being drained to the secondary drain pan which is improper.
Suggested Action Have a licensed plumber or qualified person re-route this drain line to a proper location.
Other Information The discharge point is creating chronic moisture at the foundation wall.

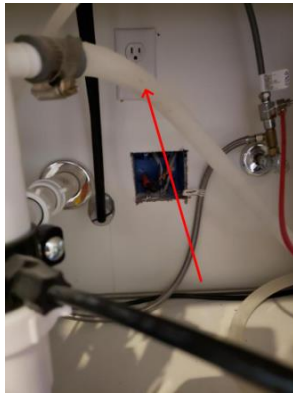
Under kitchen sink

Item Dishwasher
Concern Missing high drain line loop
Location Kitchen
Impact Without a high drain line loop, risk of a potential backflow of water in to the dishwasher and improper drainage of water is increased.
Suggested Action Position drain line to create a high loop ensuring the highest point of the drain line is above the drain entrance into the disposal.

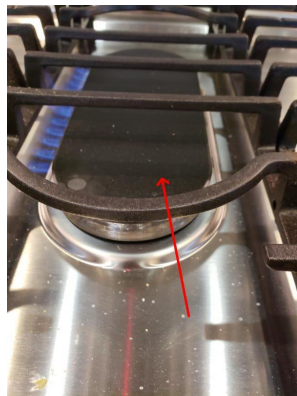
Center burner

Item	Oven/Range
Concern	Burner not operating properly
Location	Kitchen
Impact	Inability to heat as designed
Suggested Action	First, try cleaning the burner. If that doesn't work, have an appliance service technician repair the burner or replace the entire unit if desired.
Other Information	Otherwise, operating as intended.

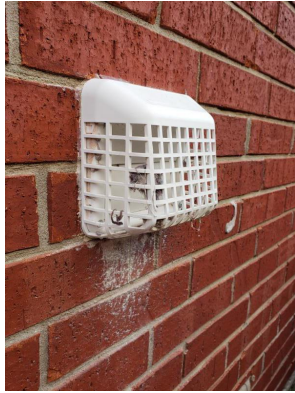
Left side of home

Item Dryer
Concern Screen at end of vent pipe
Location Exterior: Ground View
Impact Screen may cause lint to clog pipe creating a fire risk and not dry clothes efficiently.
Suggested Action Remove screen. Be sure that the vent does have a functional damper (flapper) to prevent animals, pests, and rain from entering the vent pipe.
