Inspection Report

123 Paradise Ln.

Inspection Date January 8, 2019
Client Happy Homeowner
Inspector Brandon Feltner
brandon@rangerinspect.com
TREC # 22952

PROPERTY INSPECTION REPORT

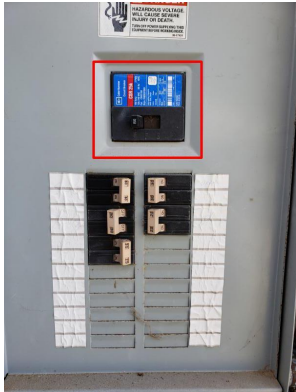
Exterior service panel

Item	Electric Service Panel
Observation	This is the main electrical shutoff for the home. This shutoff is outside so that it is accessible by first responders in the event of an emergency.
Location	Exterior: Ground View

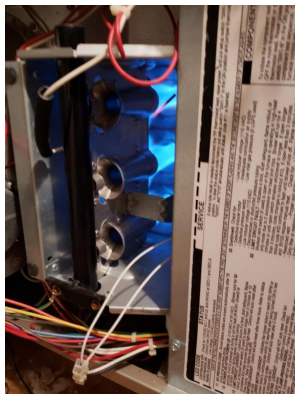
Downstairs HVAC system

Item	Furnace 2 (downstairs), Furnace 1(upstairs)
Observation	Operating as intended
Location	Main Attic

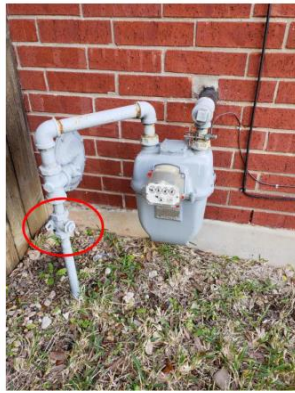
Left side of home

Item	Main fuel supply
Observation	Main Fuel Shutoff Valve
Location	Exterior: Ground View

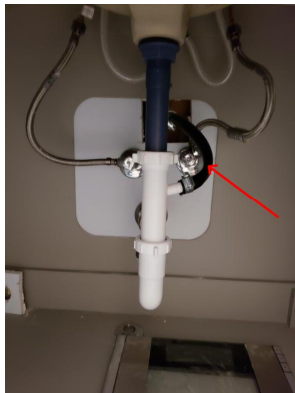
Under 2nd bathroom sink

Observation This black hose is the primary condensate drain line from the A/C. It discharges into the sink drain. This is very common.
